# Septodont Case Studies *Collection*

No. 06 - October 2013

# Racegel : Gel Retraction Material

# A four-year prospective study of the use of N'Durance<sup>®</sup> composite, a nano-hybrid resin

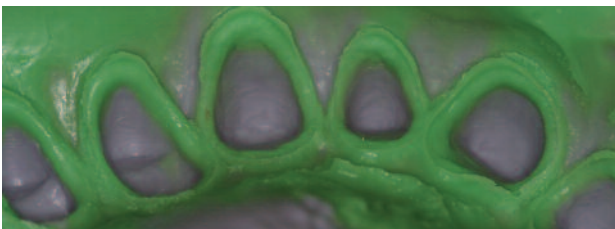
*Fig. 1:* An ideal indirect restoration impression. The material is void-free, clear of debris, and exhibits clean capture of the preparation margins.

In fixed prosthodontics, clinically acceptable impressions are an absolute necessity (*Fig. 1*). The laboratory fabricating the restoration is limited in its final quality by the quality of the incoming impression. The unfortunate reality is that most impressions are clinically unacceptable.<sup>1</sup>

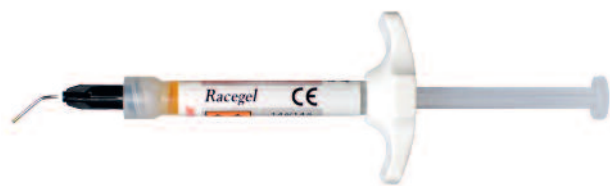
*Fig. 2:* Racegel is dispensed from a single-barrel syringe. It is colored to allow easy visualization in placement and to aid in verification of its removal.

This article will discuss impression techniques using a new gel retraction and hemostatic aid called Racegel (*Fig. 2*).

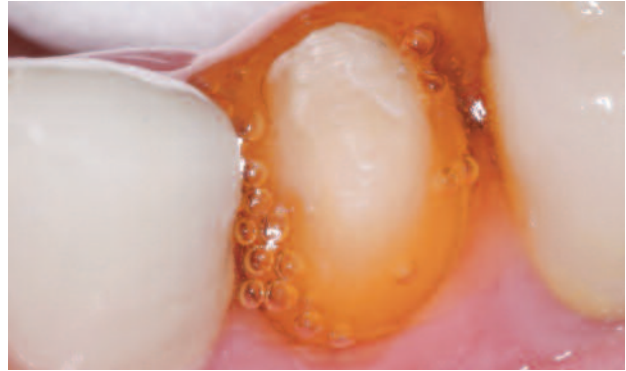
*Fig. 3:* In cases with a thinner gingival biotype, Racegel can be used as the sole source of hemostasis and tissue retraction.

This posterior crown is a common example of a low crest and deep sulcus restorative situation (*Fig. 3*). Because of the sulcus depth, often one cord is not adequate to fully displace the tissue and obtain a quality impression. Instead of traumatizing the tissue with two cords, one small cord was placed and then Racegel was injected into the sulcus. This provided the necessary retraction and hemostasis.

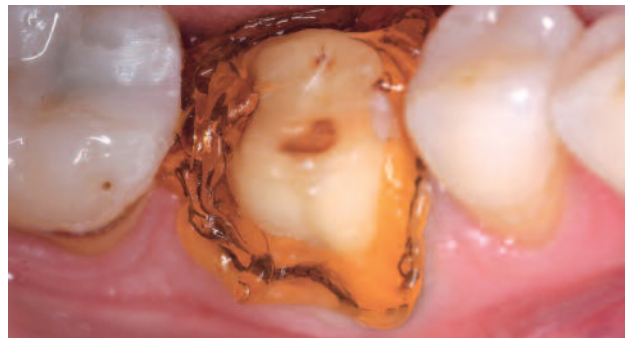
*Fig. 4:* In this case Racegel was being used in conjunction with a packed cord to control gingival bleeding and to aid in tissue retraction.

All-ceramic preparation margin designs will often be at the level of the gingival margin (*Fig. 4*). The premolar seen in this figure, which has a normal gingival biotype, can be readied for impression with Racegel as the sole source of retraction.

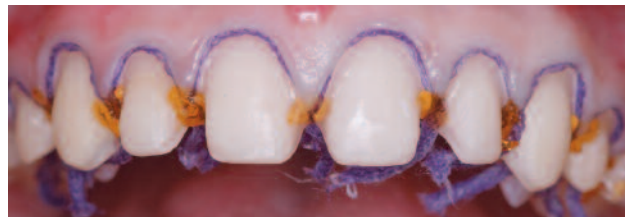
*Fig. 5:* In this multi-unit case, Racegel was used in conjunction with cord to control interproximal bleeding.

Preoperatively, this case had generalized interproximal decay and decalcification (*Fig. 5*), which resulted in residual interproximal inflammation and bleeding at the preparation visit. Dry cords were placed in the sulcus, and Racegel was placed on the bleeding areas. By controlling the tissue and obtaining a high-quality impression (*Fig. 6*), properly fitting restorations were created that allowed optimal health postoperatively (*Fig. 7*).

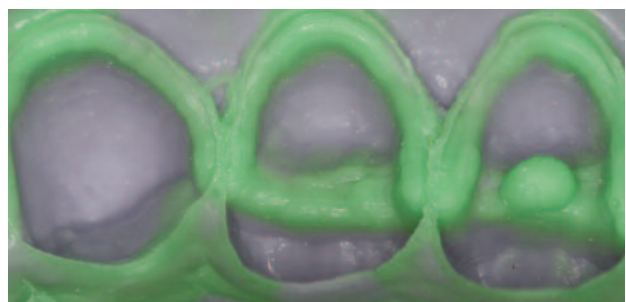
*Fig. 6:* The final impression from the case.

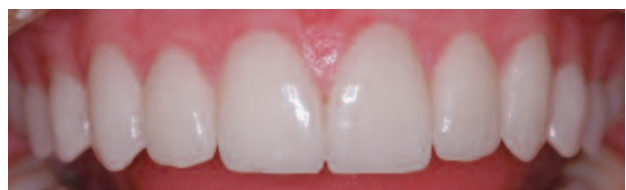
*Fig. 7:* The final lithium-disilicate veneer restorations. Note the healthy tissue response associated with properly fitting restorations.

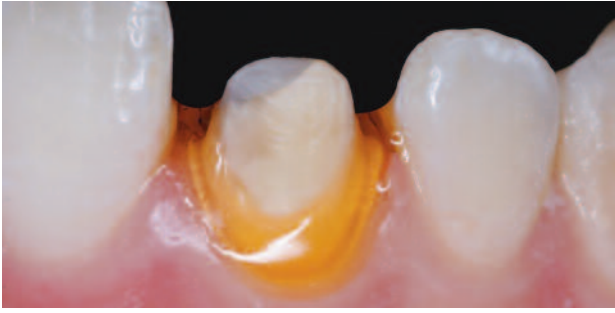
**Fig. 8:** An anterior crown preparation. This tooth had an average gingival biotype, which allowed the use of Racegel as the sole source of gingival retraction.

This anterior crown preparation was associated with a thin gingival biotype and low bone crest. To keep tissue trauma to a minimum, Racegel was used as the only source of retraction (**Fig. 8**). After 2 minutes of setting, the material was easily rinsed away, leaving a clearly exposed margin (**Fig. 9**). The resulting impression had crisp 360° margins and captured past the margin end point (**Fig. 10**).

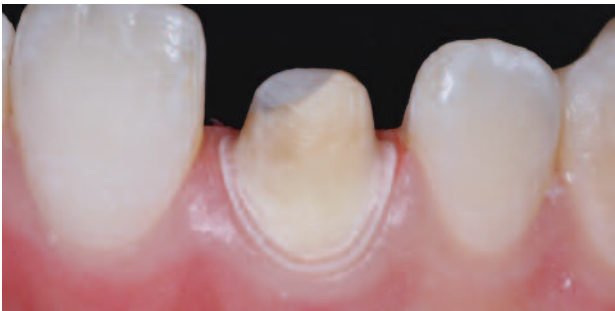
**Fig. 9:** The Racegel was rinsed away with no residue, leaving a dry, clearly exposed margin.

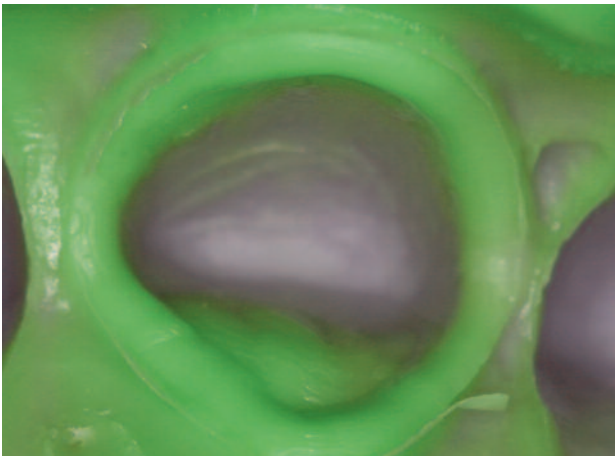
**Fig. 10:** The final impression. Note the 360° marginal capture.

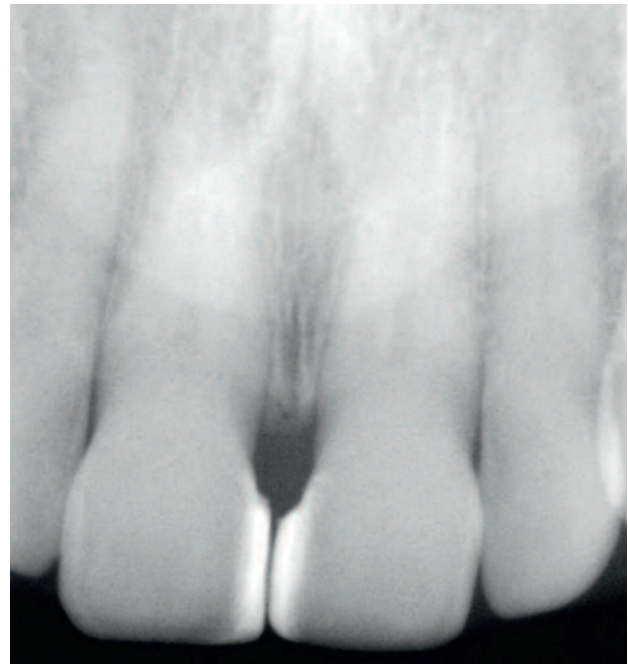
*Fig. 1*

The N'Durance® composite offers good handling characteristics, having a high viscosity and low feeling of stickiness during placement. In addition, it has a high opacity on radiographs, making it easy to differentiate it from tooth structure (*Fig. 1*).

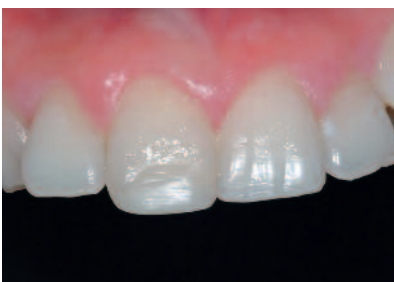
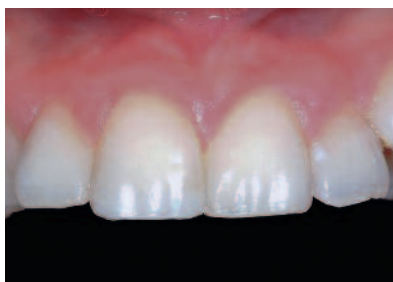
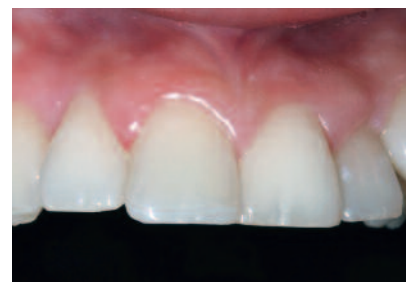
### Subject 1

Pre-operative situation

Restoration at baseline

Restoration at 4 years

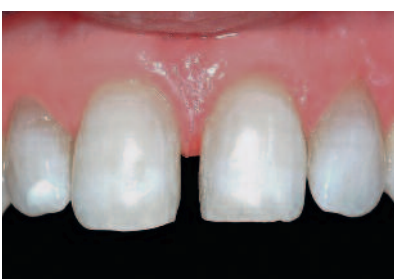
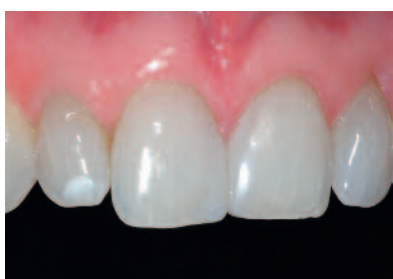
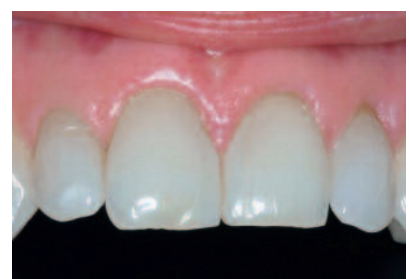
### Subject 2

Pre-operative situation

Restoration at baseline

Restoration at 4 years

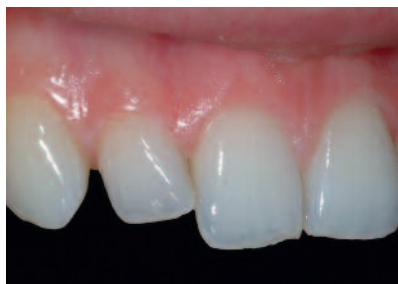
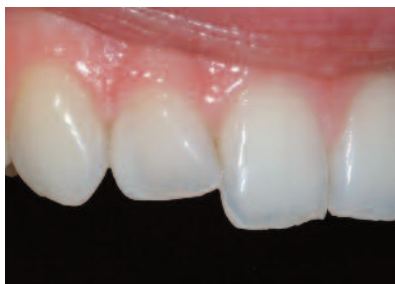
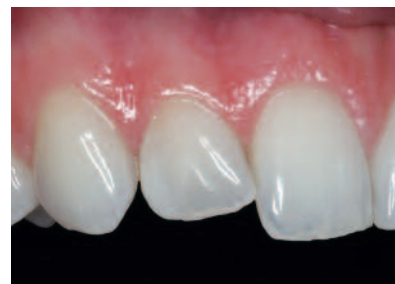
### Subject 3

Pre-operative situation

Restoration at baseline

Restoration at 4 years

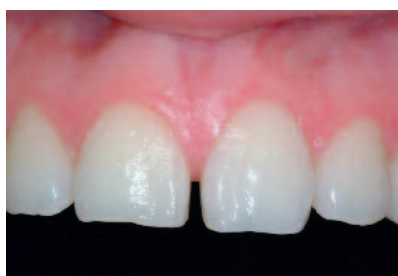
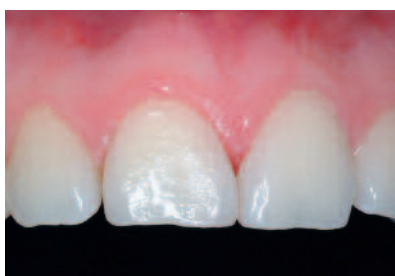
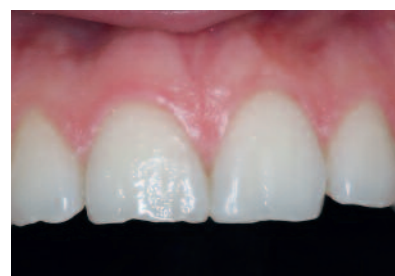
### Subject 4

Pre-operative situation

Restoration at baseline

Restoration at 4 years

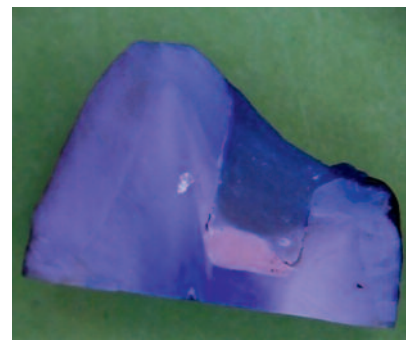
Fig. 1

been revised by the manufacturer, recommending safely the immediate preparation of Biodentine™ after its 12-minute set. Its superior in vitro performance, compared with conventional base materials (glass ionomer cements and flowable composite resins) under direct composite resin restorations bonded with self-etch bonding system, proved that immediate restoration is harmless to the cement (Tolidis et al. 2013) (Fig. 1) and that its mechanical properties are comparable to conventional base materials (Yapp et al. 2012). It could further be assumed, that continuation of setting process of Biodentine™, allows for absorption of polymerization shrinkage stresses from the overlying composite resin, resulting in preservation of excellent marginal seal and minimized microleakage (Tolidis et al. 2013) (Fig. 1).

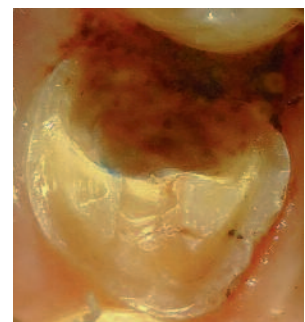
*Fig. 5*

extra care to avoid undercuts (*Fig. 5*). Biodentine™ placement fully covering the prepared cavity, waiting at least 48 hours with Biodentine™, acting both as dentin substitute and as a temporary restoration, before continuing the restorative process at the next patient visit would be the conventional procedure. Based on previous experimental studies (Yapp et al. 2012, Tolidis et al. 2013), it was decided to immediately continue with the restoration process, after Biodentine™ placement and setting. Biodentine™ was applied, right after the cavity was formed. Biodentine™ was placed in a 2-mm thick layer at the deepest part of the cavity located mesially, covering the undercuts on the pulpal wall, was condensed and was protected from moisture and allowed to set for 12 minutes according to the manufacturer's instructions. Subsequently, Biodentine™ surface was finished with a low-speed carbide bur. Dentinal walls of the onlay preparation, which were covered with cement, were finished with a low-grit high-speed diamond

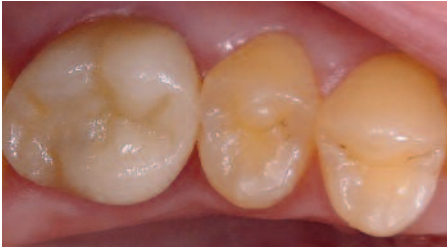
Fig. 11

ration was adhesively cemented with a dual-cure resinous cement, in order to increase retention (Fig. 11). Excess resinous cement was removed with an explorer and contact points were checked with dental floss. The restoration was light cured for 40 seconds from each side and occlusion was checked with occlusion paper and properly adjusted in maximum intercuspation and in mandibular moves. Visible margins were also finished with fine cone-shaped diamonds and silicon points. Patient was instructed for daily oral hygiene and was advised to avoid biting on hard objects or food at the area of restoration. No post-operative sensitivity or other symptoms appeared. The patient was followed-up in 6 months (Fig. 12, 13, 14). Intraoral examination, radiographs and pulp vitality testing proved the success of the material choice and of the restoration process. Reactionary dentin formation is evident when comparing the two radiographs (Fig. 3 and Fig. 14). Last but not least the mesial restoration and the tooth margins were visually checked in high magnification photograph (Fig. 13) as well as clinically with an explorer, confirming that the radiolucency shown in this area in the radiograph seems to be of no importance.

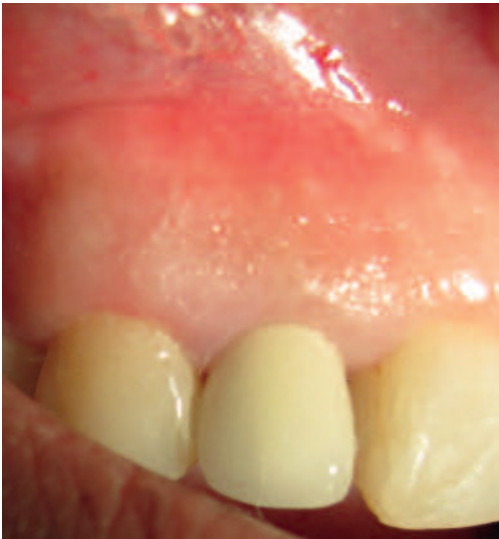
Fig. 1

We observed in the clinical examination that the tooth has a ceramic metal crown. No increase in the tissue volume was observed at the vestibular level (*Fig 1*), there is no sign of fistula, pain manifestation on palpation and vertical percussion.

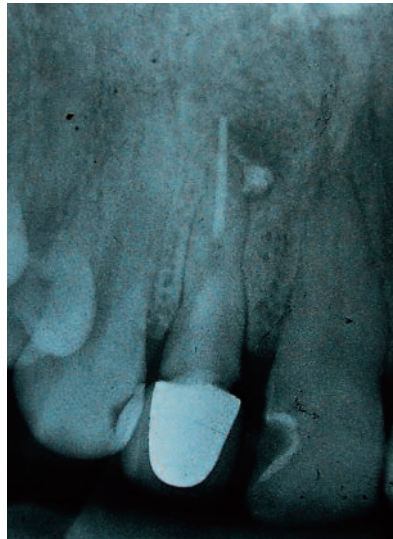
Fig. 2

The X-ray examination showed that the ceramic metal crown was not sealed at the cervical level, through the radiotransparency of the crown filling we noticed a fiber post, with absence of filling in the entire lumen of the canal prepared for the post, we also observed an over-obturation of approximately 3 mm and extravasation of the sealing cement, located in a radiotransparent area compatible with a chronic periapical process. (Fig 2)

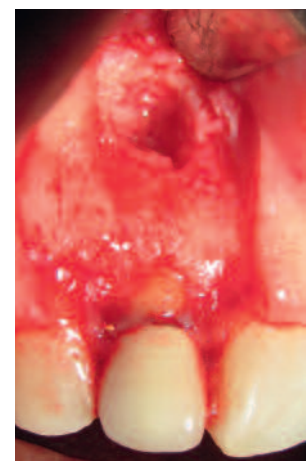
Fig. 4

curettage, the over-obtuated material and the surrounding granulomatous process was removed, and washed abundantly with saline solution to verify the removal of all the pathological tissue. The apicoectomy was performed with a fissure bur, creating as little bevel as possible and following the direction of the apical process. The apical chamber was prepared with a round bur following the direction of the root canal, at a 3 mm depth, it was thoroughly washed with saline solution and the cavity was dried with paper cones. (Fig 4)

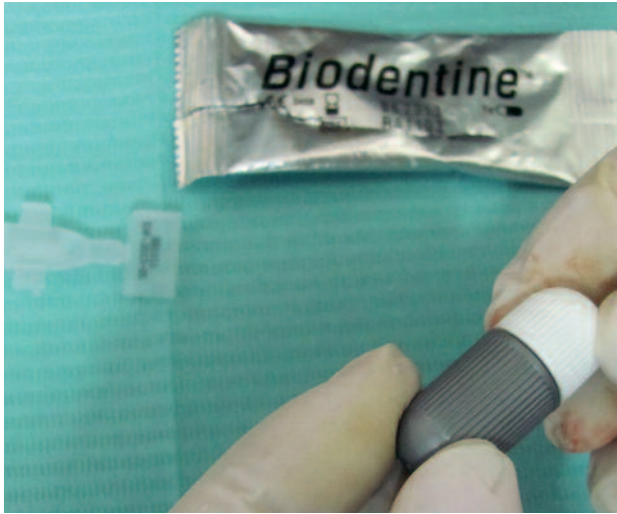
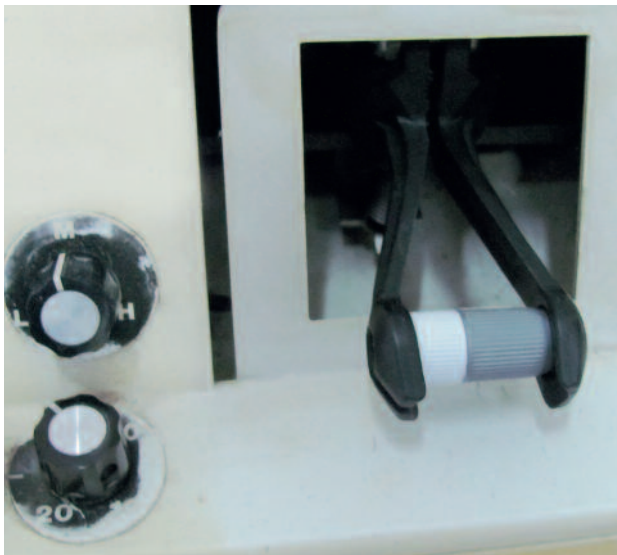
Fig. 5

Septodont's Biodentine™, an active biosilicate-based retrograde obturation material was prepared according to the manufacturer's instructions, mixing 5 drops of the liquid (Aqueous calcium chloride and excipients solution) with the powder

(tricalcium silicate) for 30 seconds in the Henry Schein amalgamator Model: HS-1. (Fig 5, 6)

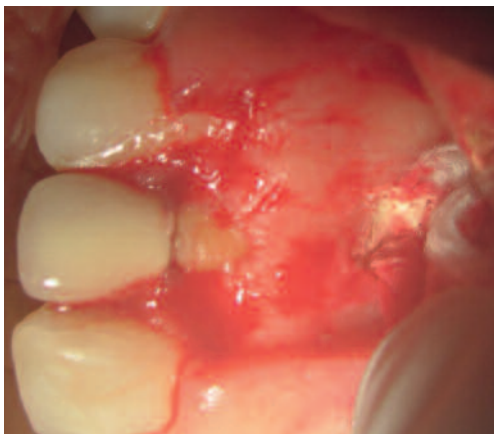
Fig. 7

We then placed the appropriate amount of material in the prepared cavity and condensed it, after 12 minutes, completely isolated from fluids, according to the manufacturer's recommendation (Fig 7), the excess was removed. (Fig 8)

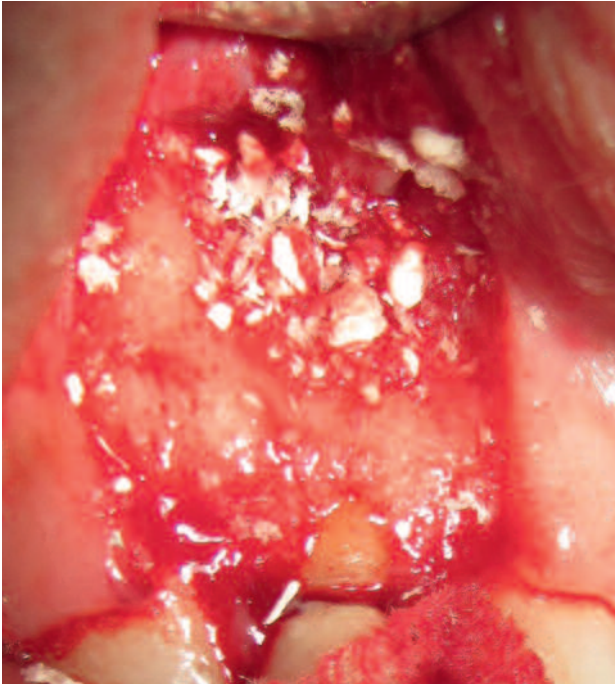
Fig. 9

We placed Genox® Org Genius-Baumer bovine liophylized bone in the cavity to fill-in the bone defect. (Fig 9)

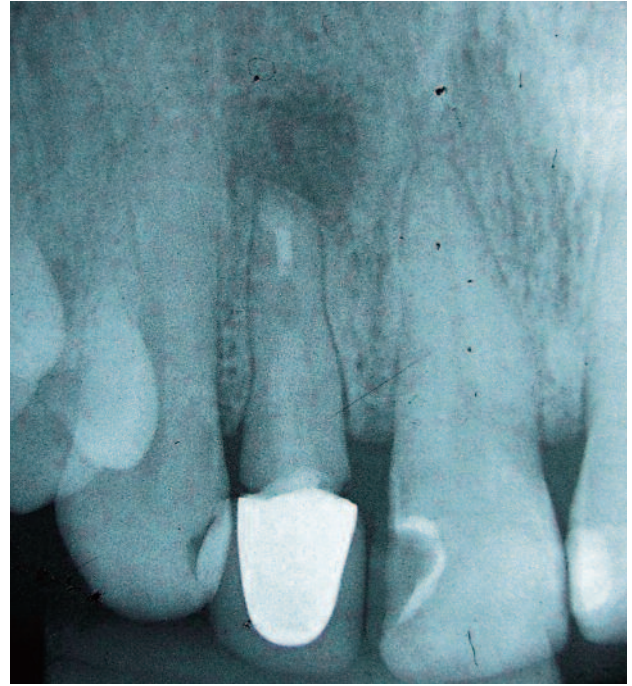
Fig. 10

We closed with 3-0 black silk suture, and treated with amoxicillin plus clavulanic acid 500 mg, every 8 hours for 7 days and ibuprofen 400 mg every 8 hours for 4 days, as well as recommending a 0.12% Chlorhexidine Gluconate mouth wash 3 times a day for 7 days. A control X-ray was taken. (Fig 10)
